# VISTA RAILING SYSTEMS INC. TEST REPORT

REPORT OF 4 FT. VISTA FRAMELESS GLASS RAILING SYSTEM TESTED IN ACCORDANCE WITH SELECTED LOAD REQUIREMENTS OF ICC-ES AC273, *ACCEPTANCE CRITERIA FOR HANDRAILS AND GUARDS*, APPROVED JUNE 2017, "FOR USE IN ONE- AND TWO-FAMILY DWELLINGS ONLY"

103705875COQ-001C

## TEST REPORT FOR VISTA RAILING SYSTEMS INC.

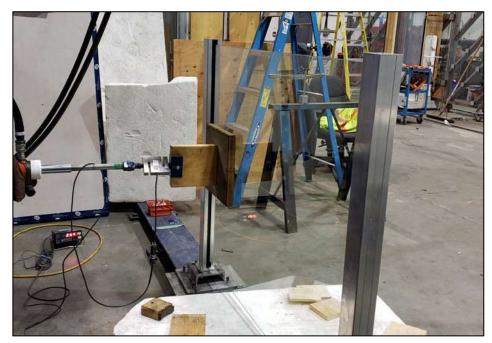
Figure 1. 4 ft. Vista Frameless Glass Railing System – In-Fill Load Test

The in-fill load test was conducted in accordance with Section 4.2.4 *In-fill Load Test* of ICC-ES AC273. Testing was conducted with reference to Section 10.4 of ASTM E935-13e1 and the load specified in Section 7.1.7 of ASTM E985-00 (2006) with a safety factor 4.0 for glass railing systems. A load of 200 lbs was applied using a 1 square foot block normal to the in-fill. After release of the load, the system was evaluated for failure, any evidence of disengagements of any component and/or visible cracking from any component.

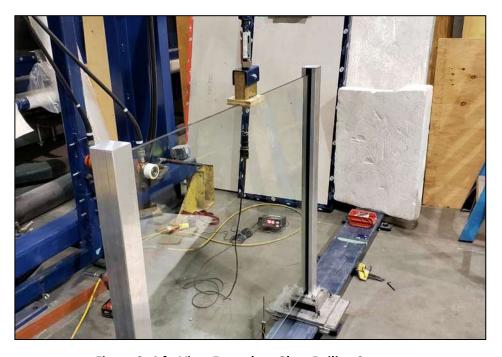
Figure 2. 4 ft. Vista Frameless Glass Railing System Vertical – Mid-Span of Top Rail Concentrated Load

The concentrated load tests were conducted in accordance with Section 4.2.6 *Concentrated Load Test* of ICC-ES AC273. Testing was conducted with reference to Section 10.6 of ASTM E935-13e1 and the load specified in Section 7.1.1 of ASTM E985-00 (2006) with a safety factor of either 2.5 or 4.0. The top rail of the guardrail system was subjected to three (3) separate horizontal and three (3) separate vertical tests where a concentrated load of either 500 lbs or 800 lbs was applied:

- horizontally at the mid-span of the top rail (800 lbs),
- horizontally at the top rail adjacent to the post connection to verify the connection capacity (800 lbs),
- horizontally at the top of the post (500 lbs),
- vertically at the mid-span of the top rail (800 lbs),
- vertically at the top rail adjacent to the post connection to verify the connection capacity (800 lbs), and
- vertically at the top of the post (500 lbs).

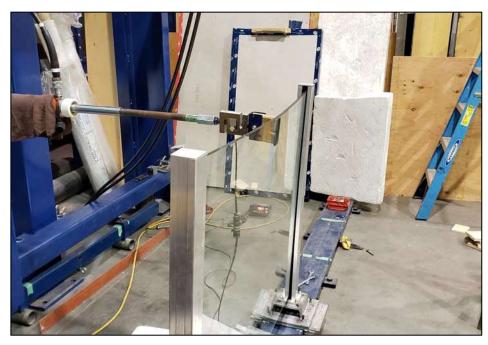
Figure 3. 4 ft. Vista Frameless Glass Railing System Horizontal – Mid-Span of Top Rail Concentrated Load

During testing, when the applied concentrated load reached 200 lbf (0.890 kN), the vertical and horizontal deflection of the top rail and horizontal deflection of the posts, measured at the point of loading, was recorded. When the load was applied mid-span of the rail, the horizontal deflection was not to exceed the sum of the rail height (h) divided by 24 plus the rail length (h) between the vertical supports divided by 96, or h/24 + 1/96. When the load was applied mid-span of the rail, the vertical deflection was not to exceed the length (h/96), where the horizontal mid-span net deflection was not to exceed L/96, where the horizontal mid-span net deflection was the measured top rail mid-span horizontal deflection reading minus the post average horizontal deflection readings. When the load was applied at the top rail adjacent to the post connection and at top of the post, the horizontal deflection was not to exceed the rail height (h/96) divided by 12, or h/12.

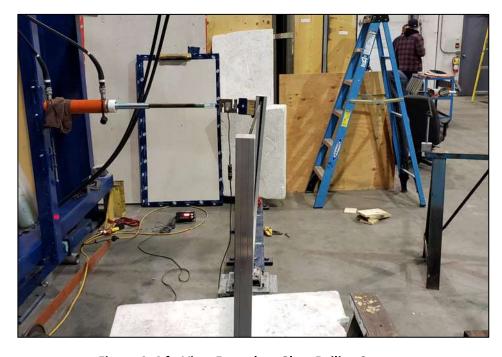
Figure 4. 4 ft. Vista Frameless Glass Railing System Horizontal – Top of Post Concentrated Loa
